Daily Activity Report

November 17, 2020

738 Upper Mountain Road Site
738 Upper Mountain Road
Lewiston, Niagara County, New York

Superfund Technical Assessment & Response Team V
Weston Solutions, Inc.
Federal East Division
Edison, New Jersey 08837

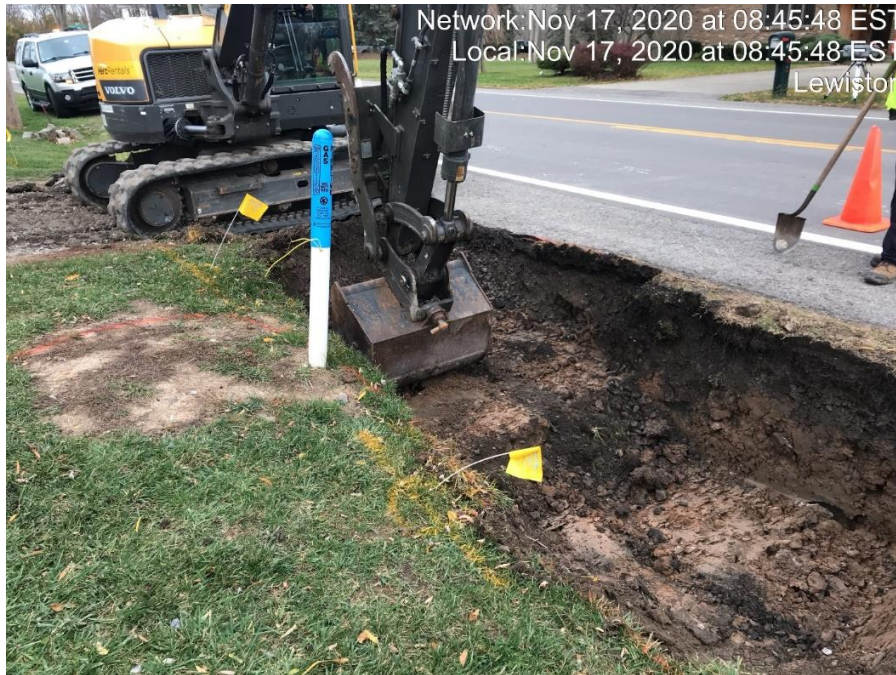
A view of ERRS excavating the area of concern (AOC) on-Site. This portion of the AOC being excavated is near Upper Mountain Road, adjacent to a gas line that was marked out during the one-call. A spotter was utilized during excavation to ensure the safety of the community and Site workers.

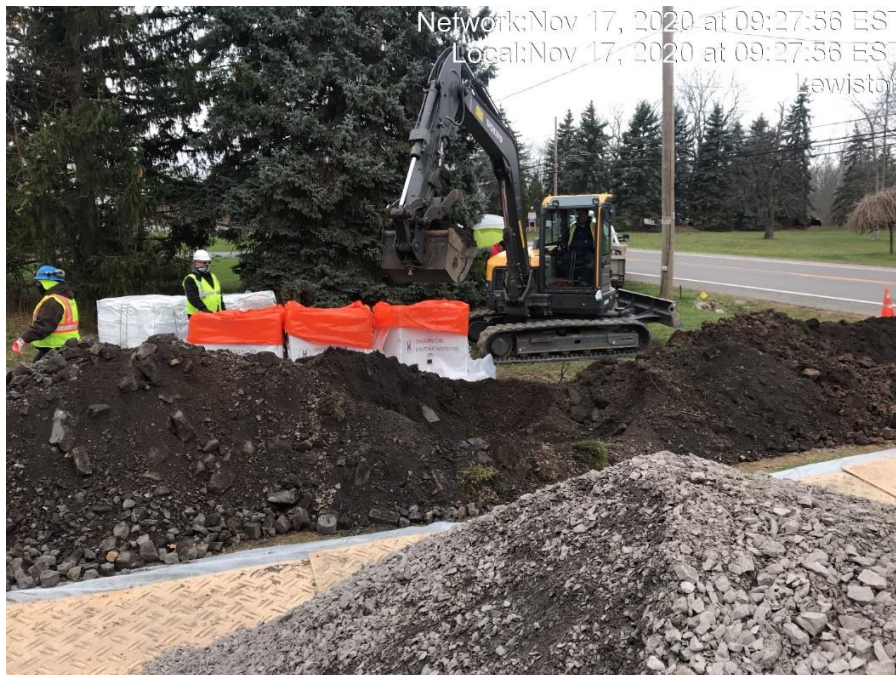
A view of ERRS loading contaminated soil into supersacks prior to their removal from the Site.

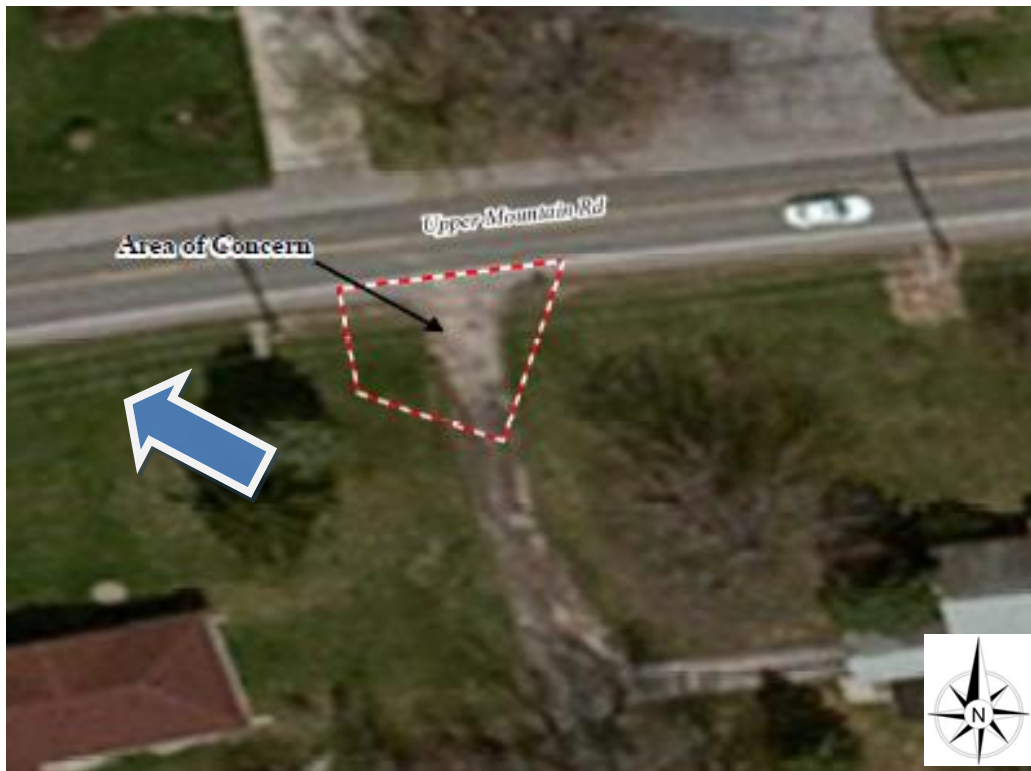
Prevailing Wind Direction:

TEMPERATURE (°F)		PRECIPITATION (inches)	WIND SPEED (mph)		WIND DIRECTION		RELATIVE HUMIDITY (Daily Average %)
<u>High</u> 38	<u>Low</u> 28	0.0	<u>High</u> 36	<u>Average</u> 18.7	<u>High</u> WNW	<u>Highest Gust</u> WNW	56

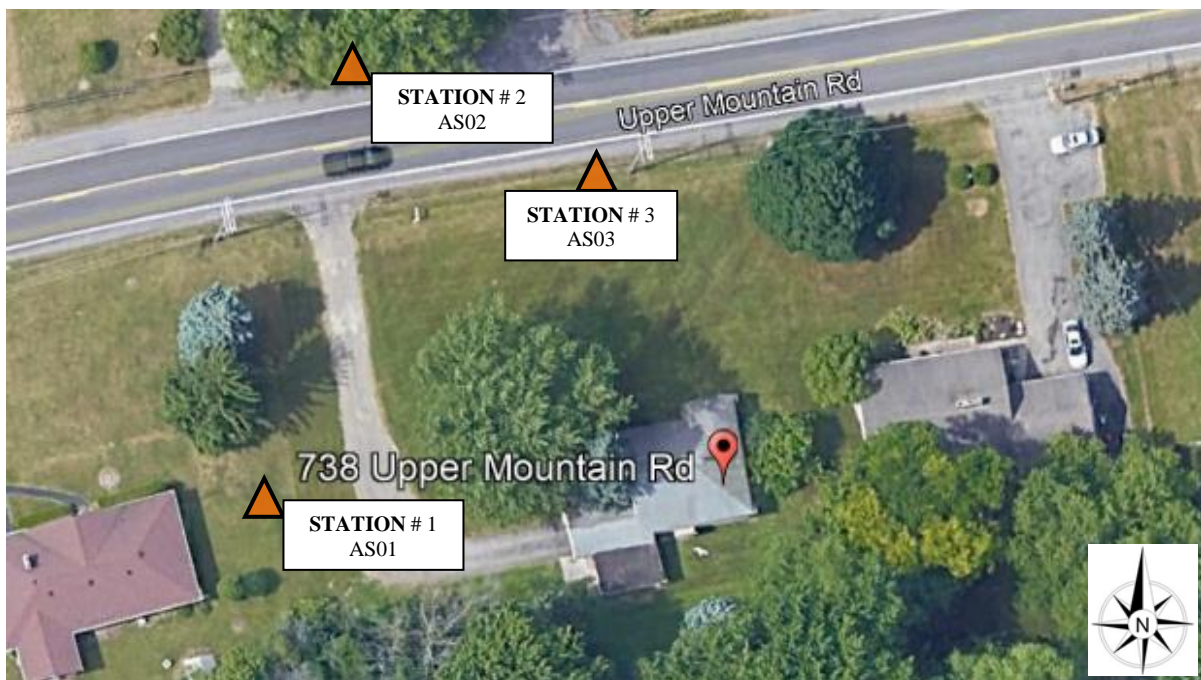
Air Monitoring Locations:

The EPA's START V contractor documented Site activities, performed air monitoring, and collected a total of four post-excavation soil samples from the base of the excavated area -on-Site. Using three Dust Track II (model 8533EP) air monitoring devices and three RADēCO (model H-810), three air monitoring stations were set up at the Site. The air monitoring locations were west of the Site facing the property owner's home (AS01), north of the Site near a telephone poll, facing the immediate excavation area (AS02) and northeast of the Site in a drainage ditch facing the immediate excavation area (AS03). The air monitoring units were calibrated before use and allowed to run for approximately 8-hours. However, due to snow, the three RADēCO units were powered down and covered for a total of 2-hours during air monitoring activities. The RADēCO units were only online for a total of 6-hours. The fugitive dust (total particulate matter) data generated during air monitoring of Site activities was compared to Site-Specific Action Levels (SSALs). Air monitoring data was below the SSAL for this reporting period.
